NORTH HORSHAM PARISH COUNCIL

PROPERTY COMMITTEE MEETING - TUESDAY 16th AUGUST 2018 (PAPERS TO ACCOMPANY AGENDA)

**Roffey Millennium Hall, Crawley Road,
Horsham, RH12 4DT**

Fire Risk Assessment

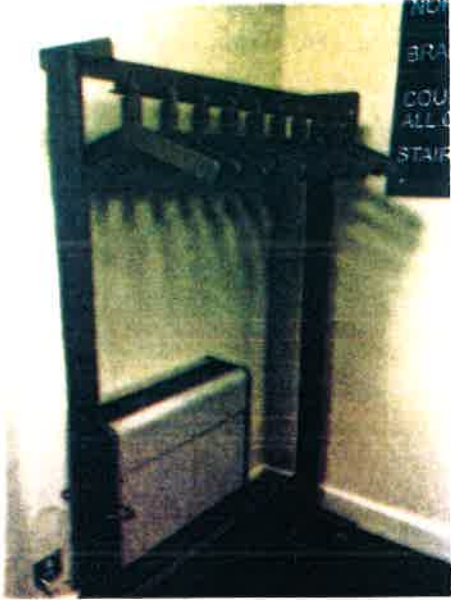
<p>1.</p>	<p>Remove the coat rack situated over a wall heater on the ground floor. Putting combustible items over a heat source will increase the risk of fire starting in this area.</p> <p>Please refer to: Step 1 - Identify the hazards</p>
<p>Priority rating: Medium - Action within 3 months</p>

<p>Coat rack over heater.</p>
<p>Task assigned to (name/company): <i>VE</i></p>	
<p>Date assigned: <i>25 / 7 / 18</i></p>	
<p>Target completion date: <i>31 / 7 / 18</i></p>	
<p>Date completed: <i>25 / 7 / 18</i></p>	
<p>Action completed on Assurity Plus (please tick)</p>	
<p>Sign off signature: <i>[Signature]</i></p>	<p>Company: <i>NHPC</i></p>
<p>Comments: <i>Email to all staff. Note to caretakers and discussions with both. All to be vigilant and if problem continues racks will be removed.</i></p>

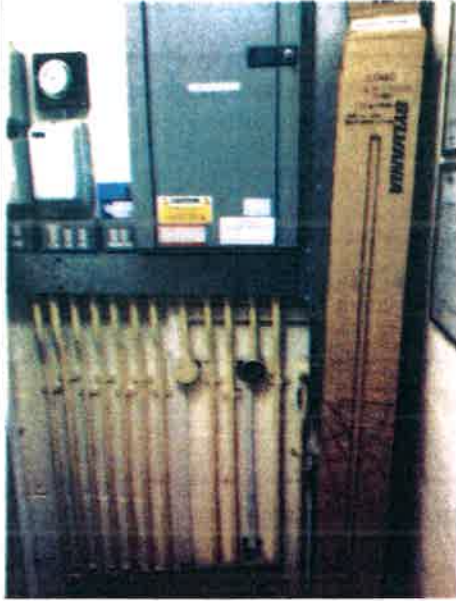
2.	Remove the combustible items left in the electrical intake room. This could result in an electrical malfunction igniting this material and fuelling a building fire. Please refer to: Step 1 - Identify the hazards	
Priority rating: Medium - Action within 3 months

<p>Cardboard boxes in electrical distribution cupboard.</p>
Task assigned to (name/company): <i>DL - all materials to be removed.</i>		
Date assigned: <i>26 / 7 / 18</i>		
Target completion date: <i>10 / 8 / 18</i>		
Date completed: <i>01 / 8 / 18</i>		
Action completed on Assurity Plus (please tick) <input type="checkbox"/>		
Sign off signature: <i>[Signature]</i>		Company: <i>NHPC</i>
Comments:

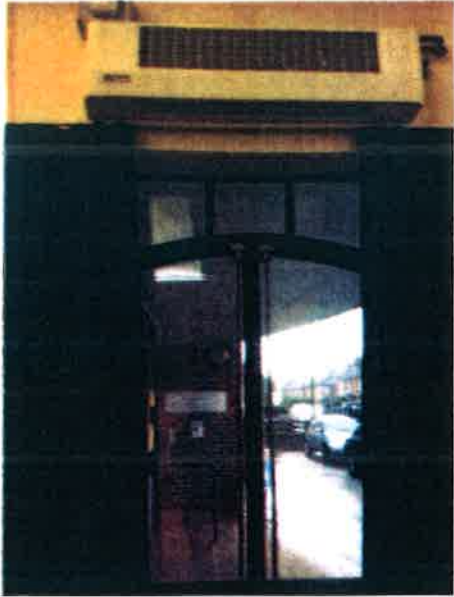
3.	Keep the curtains in the north hall clear of the over door heater when in use. This may involve the removal of the curtains or putting signage in place to advise those using the heater to keep the curtain out of the way. Having the curtains so close to a heat source is a potential fire risk. Please refer to: Step 1 - Identify the hazards
Priority rating: Medium - Action within 3 months

<p>Curtains near over head heater.</p>
Task assigned to (name/company): <i>VE</i>	
Date assigned: <i>25 / 7 / 18</i>	
Target completion date: <i>01 / 8 / 18</i>	
Date completed:	
Action completed on Assurity Plus (please tick)	
Sign off signature: <i>[Signature]</i>	Company: <i>NAC</i>
Comments: <i>Memo sent to all staff. Note for caretakers + discussion. Notices put up in both halls.</i>

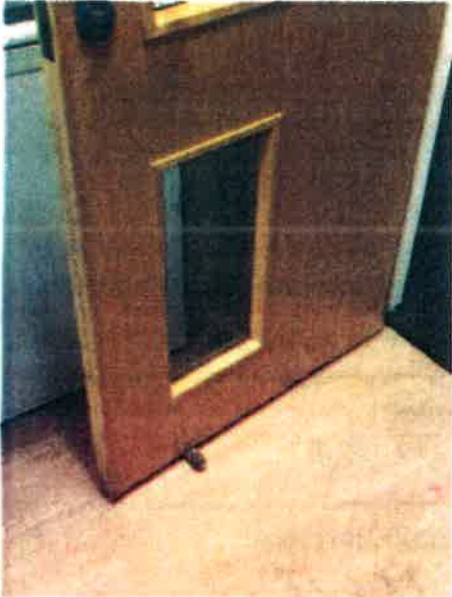
8.	Reinststate the monthly fire door checks that stopped in March 2018. I found a number of doors wedged open. * * * Please refer to: Step 3 - Evaluate the risks and decide whether existing precautions are adequate	
Priority rating: Medium - Action within 3 months

<p>North kitchen door wedged open.</p>
Task assigned to (name/company): * DL * * All staff		
Date assigned: 26/7/18		
Target completion date: ASAP 10/8/18.		
Date completed:		
Action completed on Assurity Plus (please tick)		
Sign off signature:		Company:
Comments: * Part of weekly fire alarm check * * Memo to & discussions with all staff

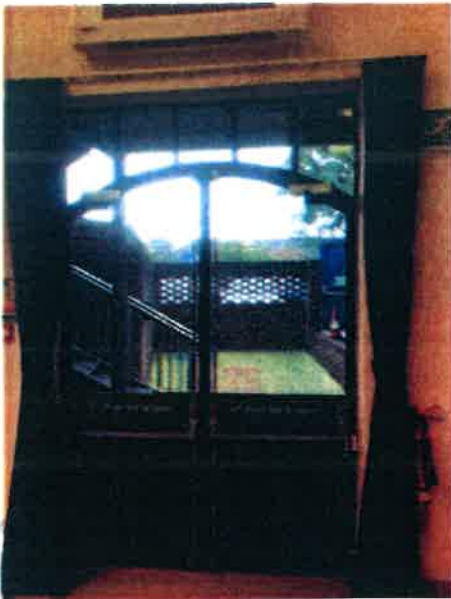
9.	Adjust the self closing mechanism on the rear fire escape door from the south hall. The effort required to open the door may make it difficult for some of the elderly users of this facility to be able to open the door in the event of fire. Please refer to: Step 3 - Evaluate the risks and decide whether existing precautions are adequate	
Priority rating: Medium - Action within 3 months

Task assigned to (name/company): <i>DL to organise</i>		
Date assigned: <i>26 / 7 / 18</i>		
Target completion date: <i>31 / 8 / 18</i>		
Date completed: <i>27 / 7 / 18</i>		
South hall door requires considerable effort to open.		
Action completed on Assurity Plus (please tick) <input type="checkbox"/>		
Sign off signature: <i>S.</i>		Company: <i>NTPC</i>
Comments: <i>Door adjusted as far as it can be. Height of door seems to be the issue.</i>

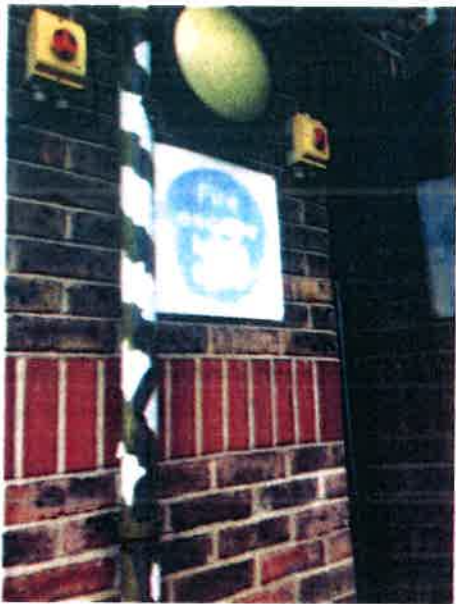
10.	Replace the faded fire exit keep clear sign in the rear fire escape area. This will help to make sure the signs are legible and adhered to. Please refer to: Step 3 - Evaluate the risks and decide whether existing precautions are adequate	
Priority rating: Low - Action within 6 months

Task assigned to (name/company): <i>JC - asked to check all signs.</i>		
Date assigned: <i>26/7/18</i>		
Target completion date: <i>31/8/18</i>		
Date completed:		
Fire exit keep clear sign by rear exit is faded.		
Action completed on Assurity Plus (please tick)		<input type="checkbox"/>
Sign off signature:		Company:
Comments:

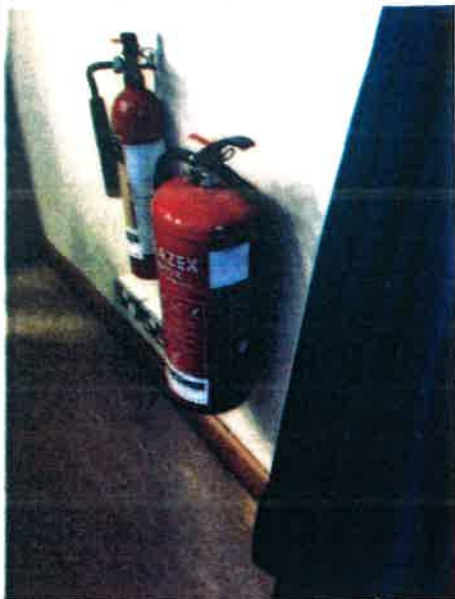
11.	<p>Consider replacing the large fire extinguishers used in the two halls with smaller ones which will be easier for users of the hall to pick up and use in the event of fire.</p> <p>Please refer to: Step 3 - Evaluate the risks and decide whether existing precautions are adequate</p>
<p>Priority rating: Low - Action within 6 months</p>

<p>Large sized extinguisher in north hall.</p>
<p>Task assigned to (name/company): <i>VE</i></p>	
<p>Date assigned: <i>Actioned before report received.</i></p>	
<p>Target completion date: <i>NA.</i></p>	
<p>Date completed: <i>14/6/18</i></p>	
<p>Action completed on Assurity Plus (please tick) <input type="checkbox"/></p>	
<p>Sign off signature:</p>	<p>Company:</p>
<p>Comments: <i>Xts changed to 6d consistors (were 9L) when serviced.</i></p>

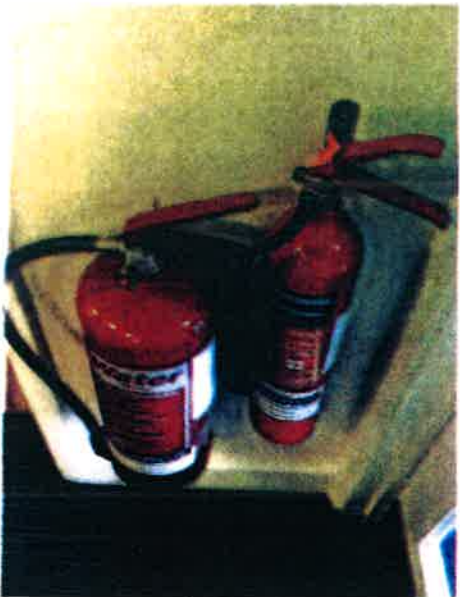
12.	Replace the missing anti tamper tag on the reception fire extinguisher. This will ensure it has not been used by an unauthorised person. Please refer to: Step 3 - Evaluate the risks and decide whether existing precautions are adequate	
Priority rating: Low - Action within 6 months

<p>Reception extinguisher missing tag.</p>
Task assigned to (name/company): VE		
Date assigned: <i>Actioned before report received.</i>		
Target completion date: N/A.		
Date completed: 14/6/18		
Action completed on Assurity Plus (please tick) <input type="checkbox"/>		
Sign off signature:		Company:
Comments: <i>Actioned when serviced on 14/6/18. Memo to staff asking them to be vigilant about missing tags.</i>

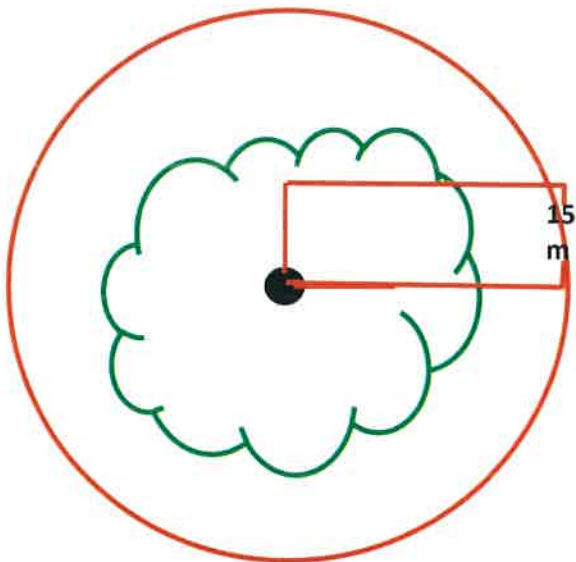
Fig 1: Optimal root medium area

fungi or other pathogens which could have resulted from physical root damage. An optimal rooting medium area for critical root function should extend radially from the tree's centre in all directions by at least 15m (fig 1) providing an undisturbed rooting medium of 707m², currently soil within this area supports closely mown grass and is subject to a level of ground compaction. Ground amelioration (Appendix 2) would help significantly in improving root function and accordingly sustainable tree physiological condition. The basal trunk area was well buttressed, indicative of age and the laying of structural reaction wood. Sinuses between buttresses contained sound wood with no frictional damage or decay. No pathogenic colonisation was visible within the rooting medium, surface roots or basal trunk area e.g. fungal fruiting bodies or significant pathogenic decay.
